SIMULATION TEST REPORT

Bi-Level Motor Vehicle Securement Systems With Bi-Level and Tri-Level Products

TEST REPORT: VL 2 - 09

SUBJECT: Test of Motor Vehicle Bi-Level Securement Systems With Bi-Level and Tri-Level Products

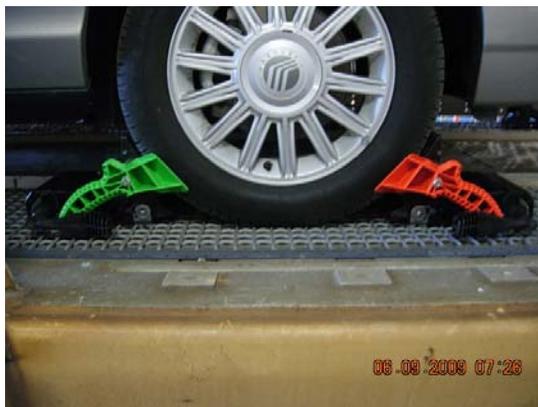
View of Holden America's system.

The **Holden America** system is an eight chock per vehicle system (2 chocks per wheel) that attaches to the chock grating currently equipped on most of the bi-level fleet. Vehicles are secured by a colored coded chock applied inboard and outboard of each tire. A Lime green colored chock is applied to the **Left** side of the tire as a loader faces the tire, and a **Red** colored chock is applied to the **Right** side. The chock is constructed with a platform that attaches to the grating and when the locking handle is engaged the faceplate and upper portion of the chock moves forward to fill any void space between the tire and faceplate. The lateral restraint provision is applied to the outside of the tire. This lateral restraint is angled so that it contacts the outer tread area of the tire and not the sidewall. The chock is adjustable in height.

HOLDEN AMERICA – There was no problems with clearance issues with the vehicles (Lincoln Grand Marquis and Toyota Sienna) secured with this system. The Holden America system uses 8 chocks per vehicle, 2 chocks per wheel. This fact obviously requires more chocks and storage means as well as positioning 8 chocks is more work and time than positioning a lesser number. The actual application of each chock is fast and easy to accomplish. The color coded system works very well. The system is designed so a portion of the chock moves to contact the tire which will reduce any void. Removal of all voids is a great feature; however, moving parts are always a concern from a maintenance perspective. This feature must be observed over time. During the test the system performed as designed. The chock feels out of balance and is relatively heavy to handle with one hand as much of the weight is away from the handle position.

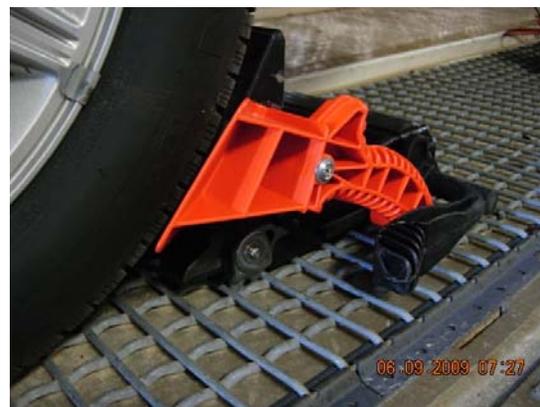
View showing lateral restraint paddle.

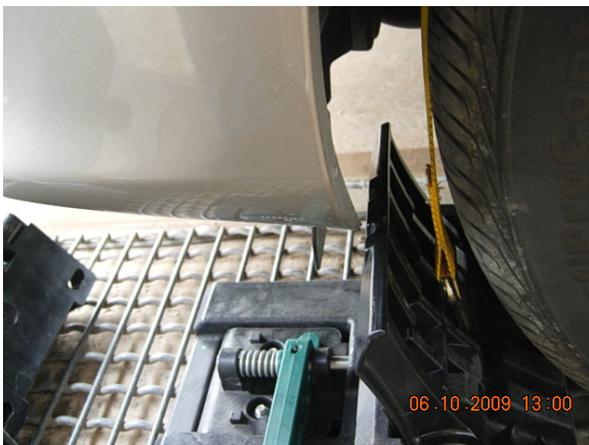
View showing close clearance between chock and vehicle.

ZEFTEK – After installation of the securement system, there was only 1 inch clearance between the chocks and the ground effects at the front of the A-1 vehicle (Toyota Corolla), a tri-level product. This was observed and monitored throughout the test and at the conclusion it did not appear that there had been any contact. There was adequate clearance between chock and body components of the other vehicle (Toyota RAV) secured with the ZefTek system.
